**Project:** Sustainable Restoration of Highway Structures: Cathodic Protection (CP) of Concrete Structures Along the Danube River Bank Highway A22, Vienna (A).

**Subject:** Description of the Project

**Date:** 05. 08. 2010

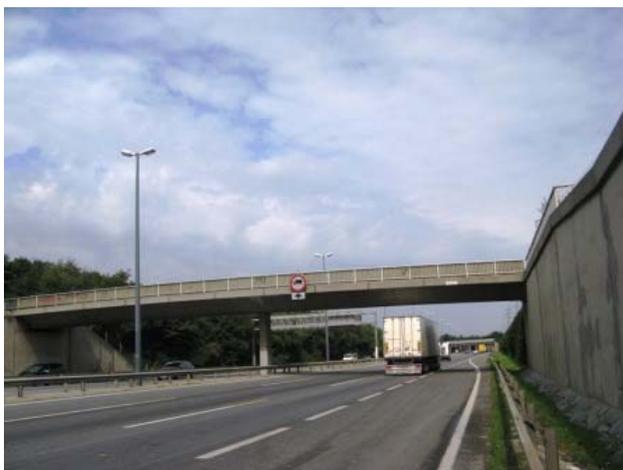
*Figure 1: Bridge B2134 crossing the Danube river bank highway A 22.*

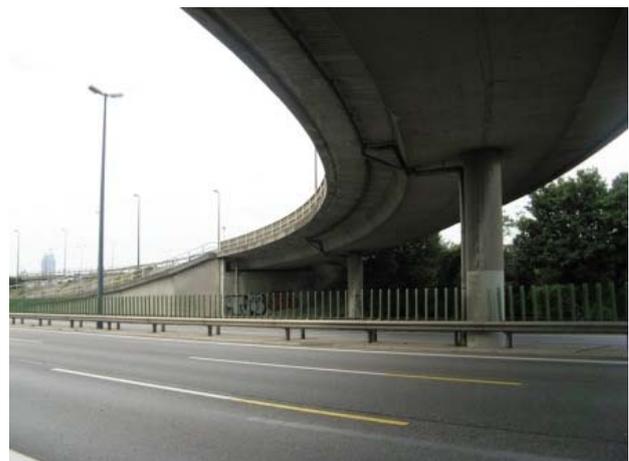
*Figure 2: Highway Ramp B2136 to the Danube river bank highway A 22.*

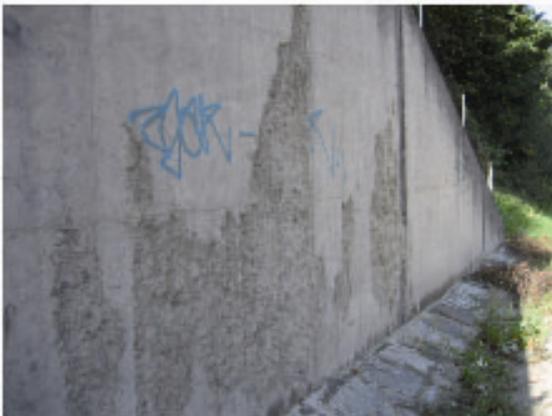
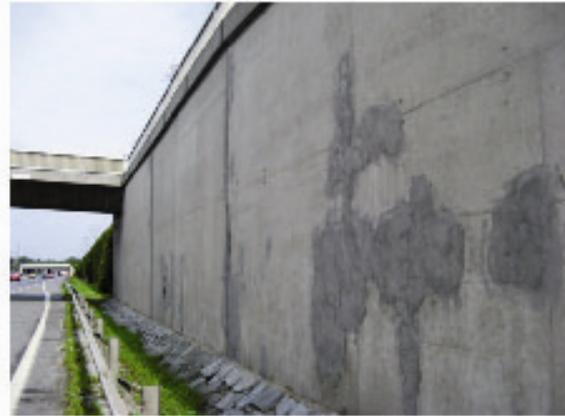
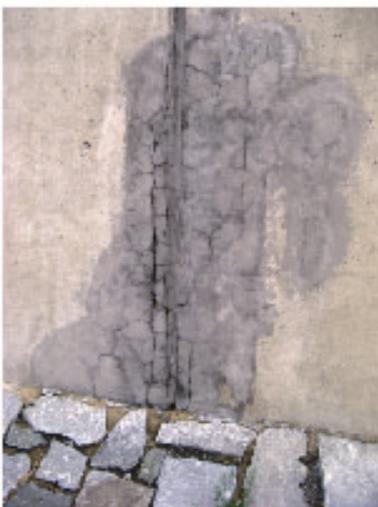
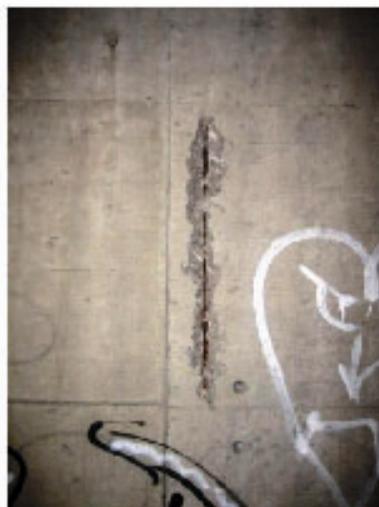
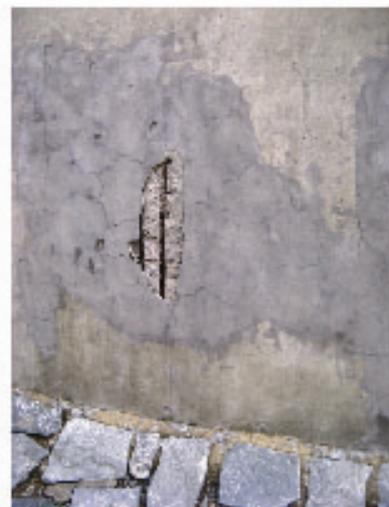
According to the results of the steel potential mapping, a high risk for corrosion of the steel reinforcement persists in all evaluated structures (abutments, walls and bridge columns). The chloride content in the concrete overlay is significantly above the critical value of 1 M% per weight of cement according to the national standard ÖNORM B 4706. The values for the chloride content 1,5 cm – 3,0 cm below the concrete surface range from 1,4 to 5,2 M%/ weight of cement, and near the concrete surface (0 – 1,5 cm) from 1,5 to 7,8 M%/ weight of cement. The depth of carbonation of the concrete overlay is in the range of 0,6 to 3,0 cm, in to weathering exposed areas in the range of 2,5 – 3,0 cm – thus in the range of the first layer of steel reinforcement.

As a result of the high chloride contents, there is a high risk for active corrosion of the steel reinforcement, corroborating the results of the potential mapping. Damages in the concrete overlay due active corrosion of the steel reinforcement were repaired during the past years by conventional repair with cement mortar with limited success with regard to its durability (figure 3 & 4). With regard to the high chloride contamination of the concrete up behind the first layer of the steel reinforcement and with regard to the associated high corrosion risk, CP is the most efficient, sustainably and durable method for the restoration.

**Visible Damages Caused by Steel Corrosion**

*Figure 3: Visible damages to the sustaining wall of the bridge B2134.*

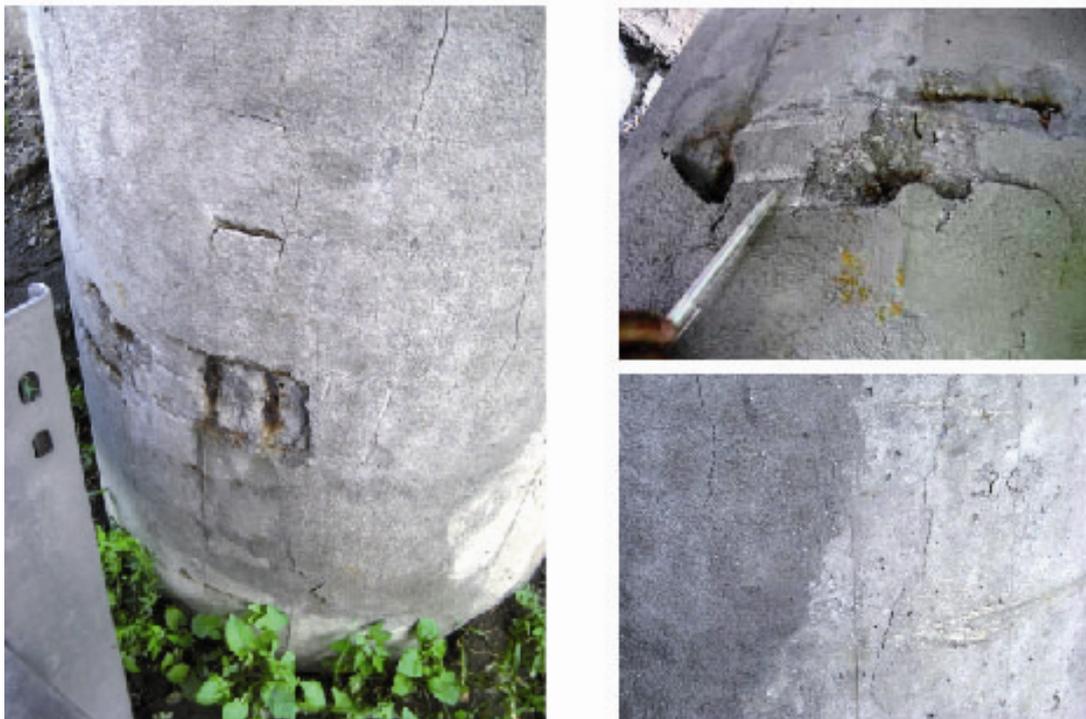
**Visible Damages Caused by Steel Corrosion**

*Figure 4: Visible damages to the bridge columns of the bridge B2136.*

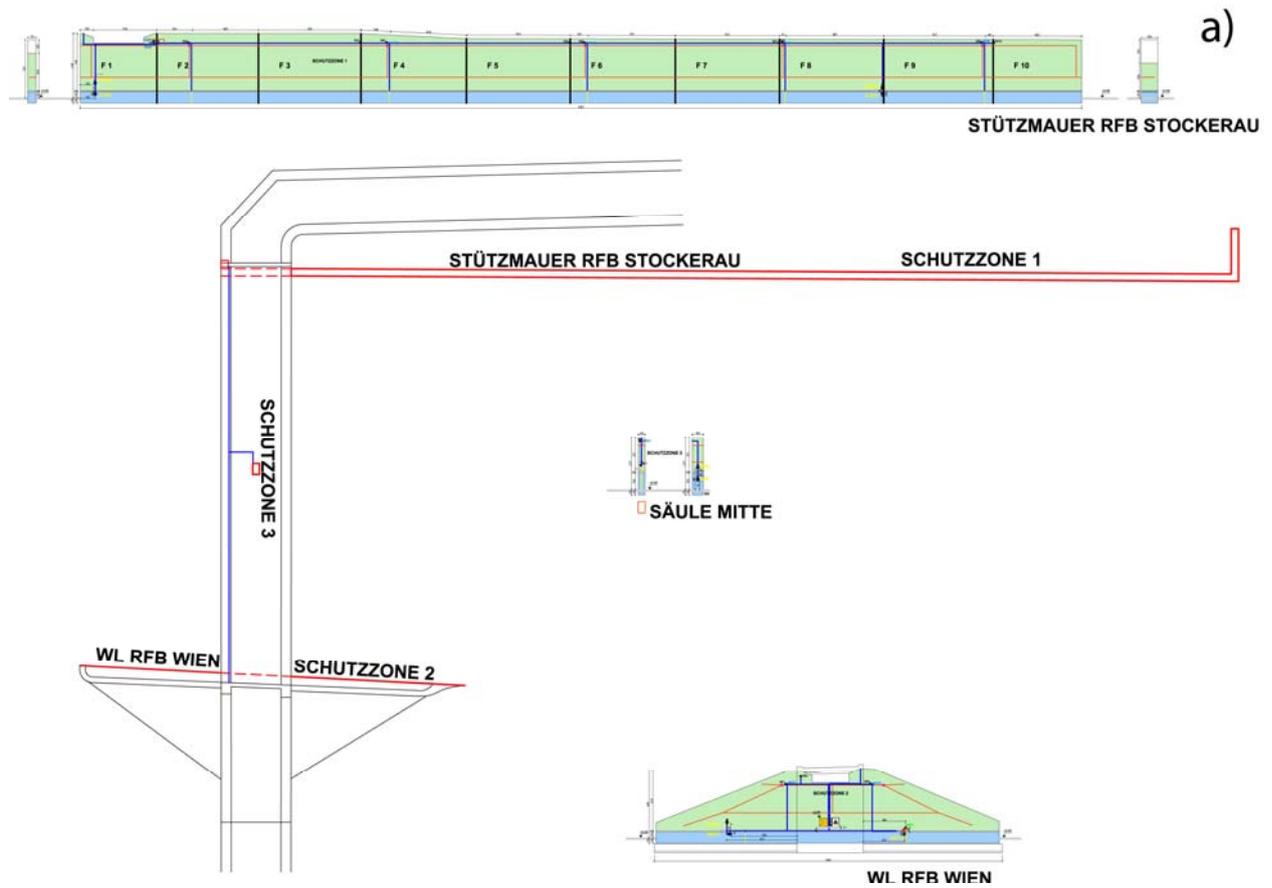
Figure 5: Schematic representation of the CP protection zones & anode system: B2134, sustaining wall – zone 1, bridge column – zone 3, abutment – zone 2.

Overall, five protection zones were defined, one zone per structure (figure 5 & 6). Dimensions, installed sensors and CP-components are summarized in table 1.

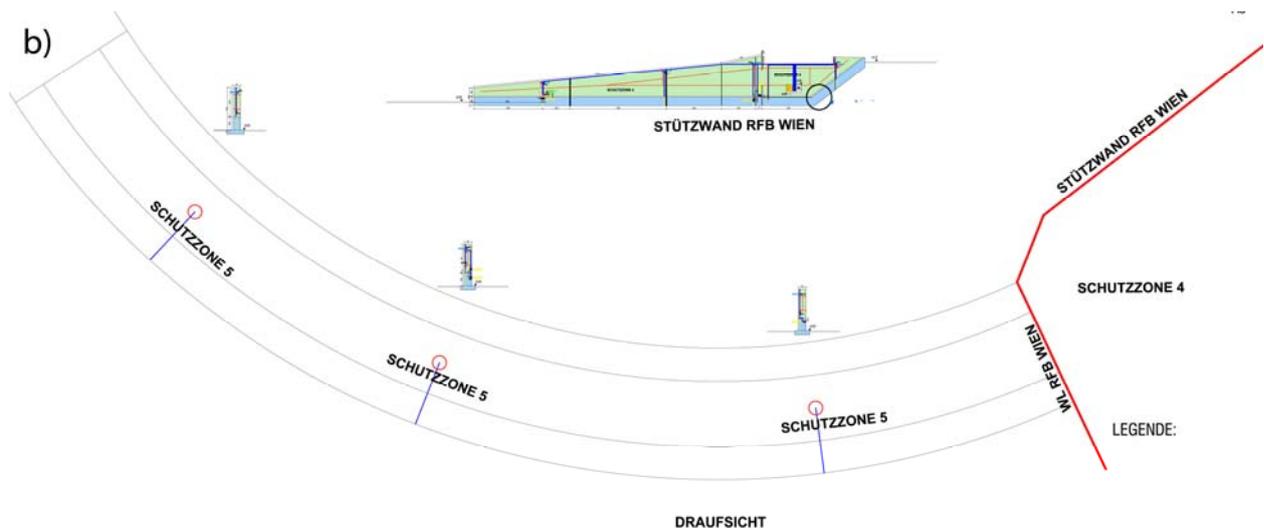
Figure 6: Schematic representation of the CP protection zones & anode systems: B2136, abutment and sustaining wall – zone 4, three bridge columns – zone 5.

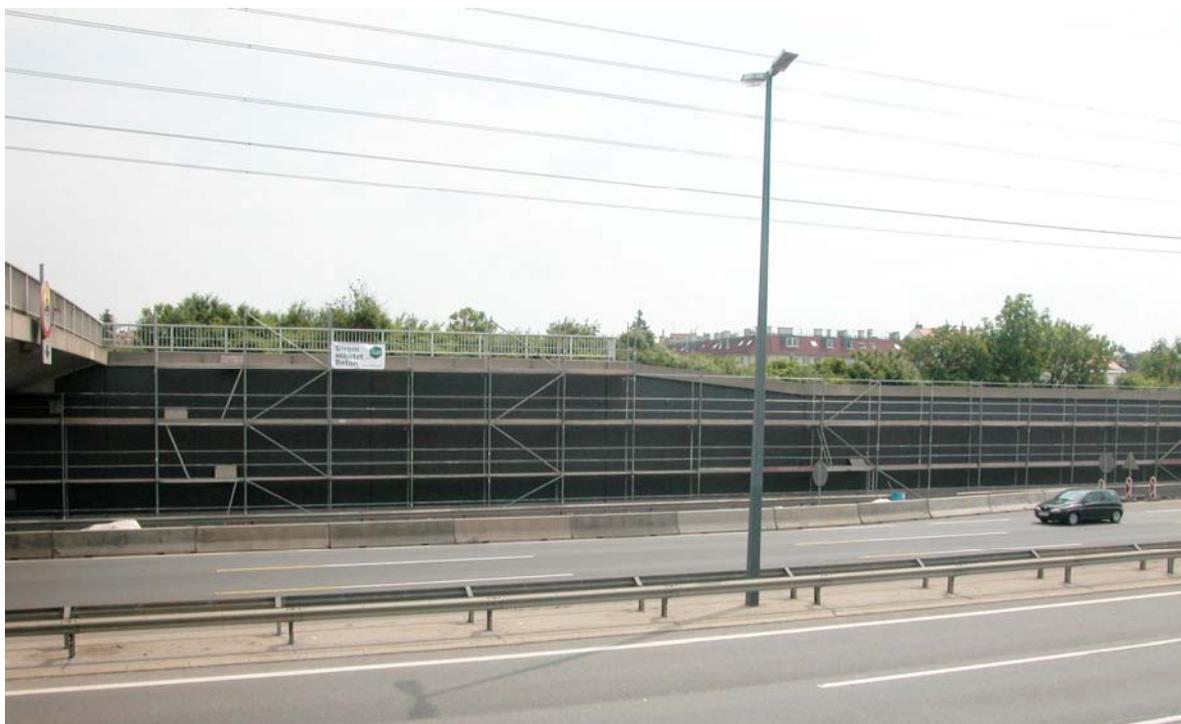
*Figure 7: Installation of the CAS-Composite Anode in Zone 1 (sustaining wall, B2134 RF Stockerau) – 1<sup>st</sup> layer of CAS-T<sup>+</sup> coating.*

Sensors – reference cells, macro-cell sensors – were installed in the concrete according to the standard practice. The first layer of the CAS-T<sup>+</sup> coating was applied on the fully hardened cement plaster (figure 7).

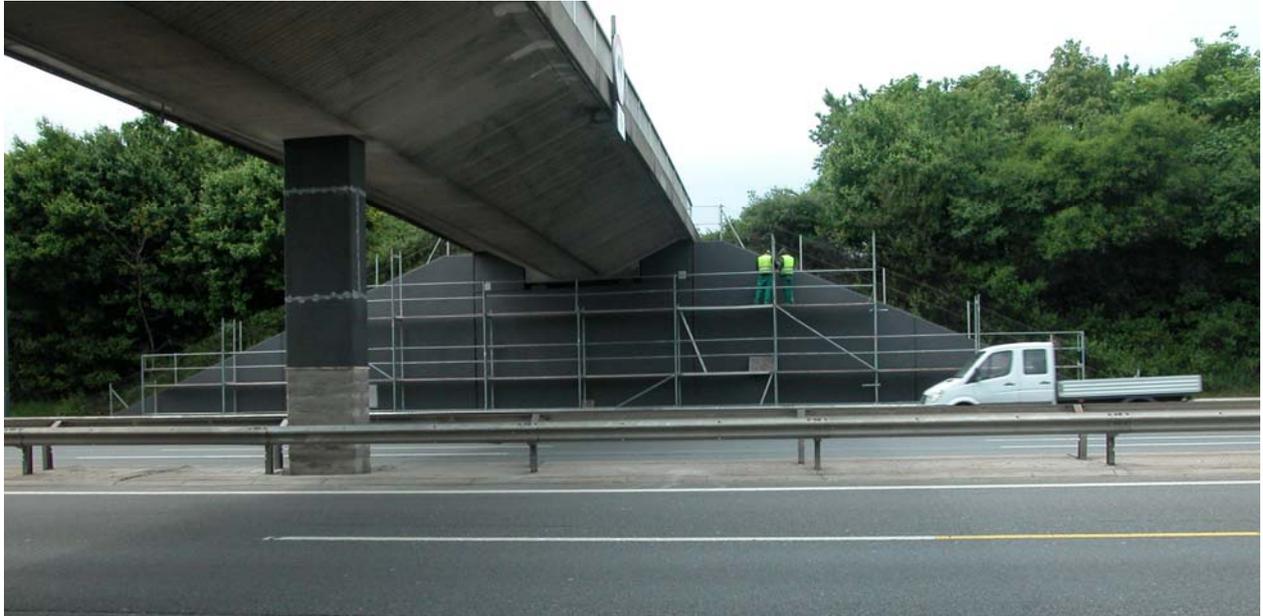
*Figure 8: Installation of the CAS-Composite Anode B2134: bridge column – zone 3, CAS-CNP primary anode on 1<sup>st</sup> layer of CAS-T<sup>+</sup> coating; abutment – zone 2, second layer of CAS-T<sup>+</sup> coating embedding the CAS-CNP primary anode.*

The CAS CNP primary anode was installed on the first CAS-T<sup>+</sup> layer and covered with a glass-fiber ribbon-mesh (figure 8). The CAS CNP primary anode was then embedded into the second layer of the CAS-T<sup>+</sup> coating (figure 8). The CAS Composite Anode was then covered with two layers of a frost-thaw salt proof acrylic coating (figure 9).

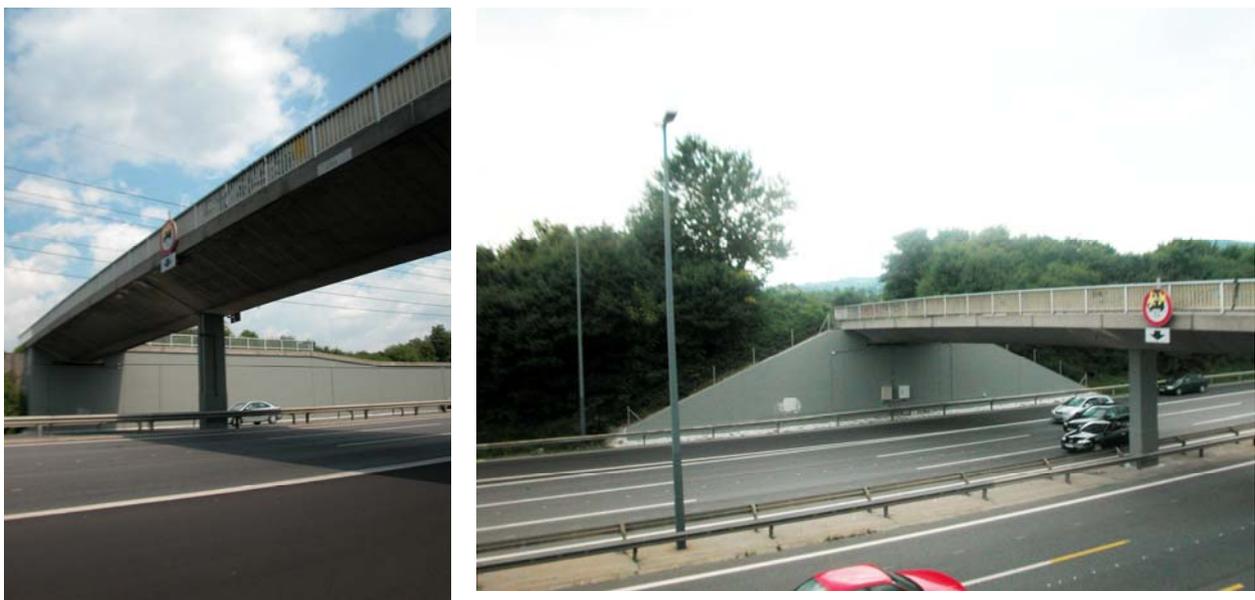
*Figure 9: Coating of the CAS Composite Anode with a cover coat (Sikagard 550W elastic) on the structures of B2134*

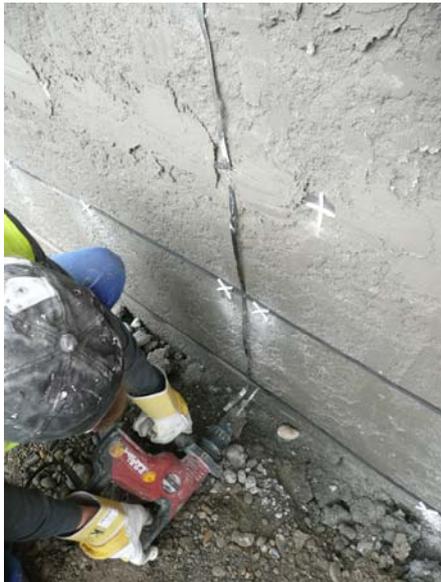
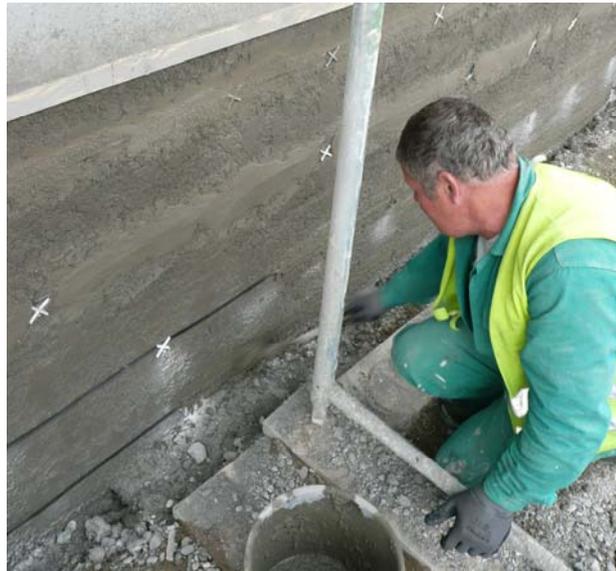
*Figure 11 Titanium ribbon mesh anode on the sustaining wall above and below the ground line, B2134, zone 1.*

The concrete surface areas on which the titanium-ribbon-mesh anodes were to be installed were treated with high pressure water jetting. The titanium-mesh-ribbons were applied on top of a thin mortar sludge layer, fastened to the concrete with appropriate synthetic dowels (figure 11) and embedded into shotcrete (figure 12). After completion of the installation works, the mortar was covered with the same acrylic coating as the CAS Composite Anode.

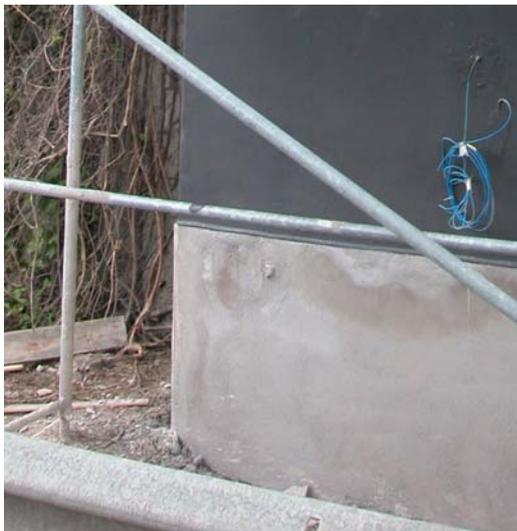
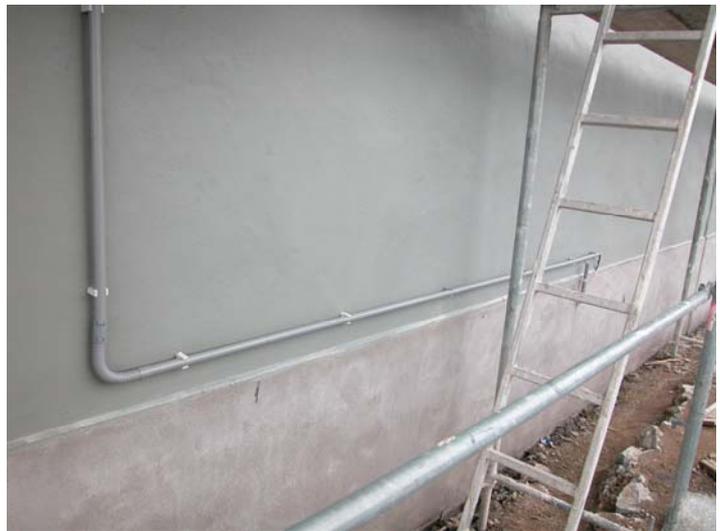
*Figure 12: Installation of the titanium ribbon mesh anode on the sustaining wall above and below the ground line, embedded into shotcrete, left picture zone 1. B2134; right picture zone 4, B2136.*
